Missed Foreign Body Falsely Interpreted as Glass in Surgery

ABSTRACT

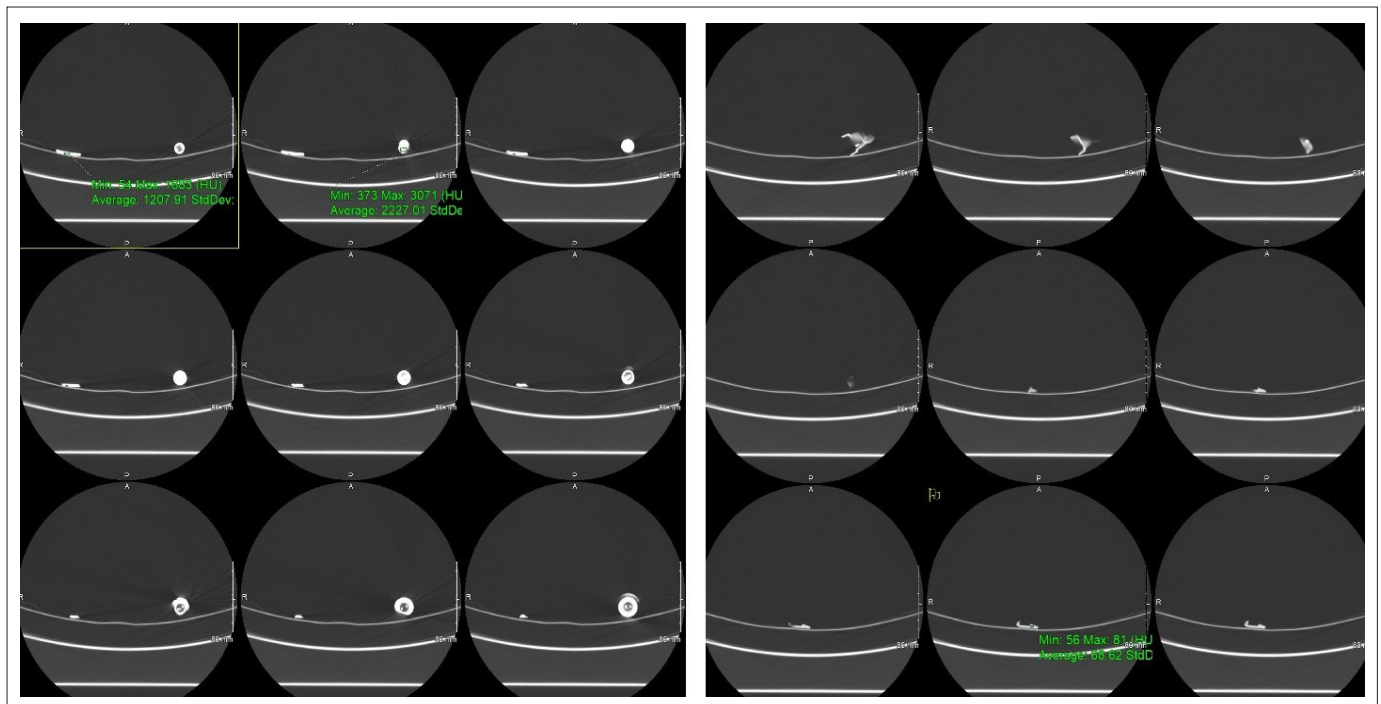
Figure 3 : Phantom CT of glass (HU 1207.91), metal (HU 2227), and plastic (HU 88.62) from a broken taillight imaged in the same CT scanner the as the patient was imaged in.

studies (Table 1). Plastic from an automobile light in the CT scanner at our medical center had a HU of 88.62 (figure 3), and the study was dictated as a hematoma. A hematoma usually has a HU of 40 - 60 (Table 1); depending on the onset (acute or chronic), the HU can range from 28 - 82 (Singh, 2017) because of the difference in calcium and iron based on the time. Identifying that car taillight plastic averagely attenuates at 88.62 HU at our institution highlights an area of improvement that hematoma should not have been suggested. The purpose of this case is to prevent further deleterious events from happening in the future. Based on the medical record, a piece of glass was pulled out of the surgical wound, this is not probable because glass has substantially higher attenuation than plastic on CT (Table 1). In addition, if the FB was glass, it would have likely been easily identifiable on x-ray due to the radio-opacity of glass.

*Plastic had lots variety of HU in the literature ranging from -100 to 500 (Alfuraih 2022, Carneiro et al., 2020, Modjtahedi 2015, Tseng 2015) The values of 10 - 100 were chosen because it most closely encapsulates the most common values seen in the literature. (Alfuraih 2022) had plastic attenuating at 73 HU which resembled the CT scanner at the hospital it was imaged on (can be seen in Figure 3)
