# Missed Foreign Body Falsely Interpreted as Glass in Surgery

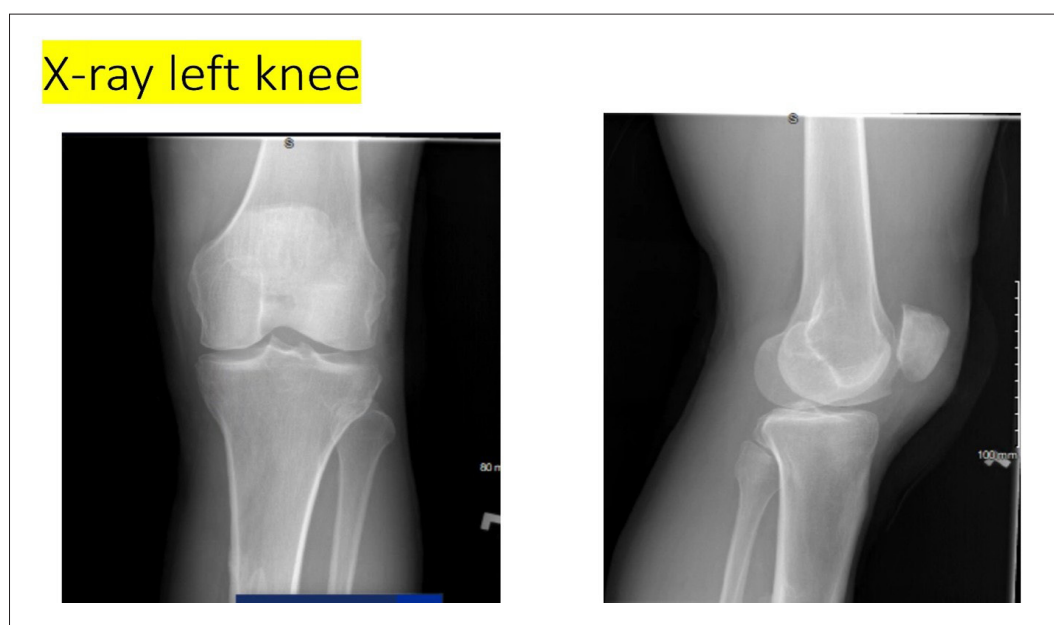
**Figure 1:** AP and lateral plain radiograph of the left knee

Conventional x-rays were ordered of the femur, knee, tibia, and fibula, all revealing no acute osseous abnormality (Figure 1). Specifically, the CT knee demonstrated "no acute fracture or dislocation. No osseous erosive process. No significant knee effusion. Small amount of soft tissue air, likely due to injury in the prepatellar soft tissues, correlate clinically. Small hyperdensity is seen anterior to the patella likely due to small hematoma measuring 1cm x 0.5cm with prepatellar soft tissue swelling" (Figure 2).

Based on the case presented above, the FB was missed on plain film (Figure 1) and recognized on the CT scan (image 2) but dictated as a small hematoma. This is a common theme; a study done in vitro demonstrated that no reader could visualize plastic on x-ray, but could identify glass and metal (Alfuraih et al., 2022). This finding was further corroborated by (Ingraham et al., 2015) using their pig phantom model, 2 out of 5 (different types of plastic) were visible on conventional x-rays. The reason is that radio-opacity is related to atomic number. Plastic is made of hydrogen, carbon, oxygen, and fluorine; depending on the composition, the atomic number ranges from 5.44 - 8.43 (Phelps et al., 1975). Soft tissue has an atomic number of roughly 7.5; because the difference between the atomic numbers is negligible, there is no contrast between the mediums, which makes neither medium differentiated from the other in plain radiography (Pinto et al., 2014). In contrast, the atomic number of metal is significantly greater than that of soft tissue; it is radiopaque and is clearly differentiated from soft tissue.

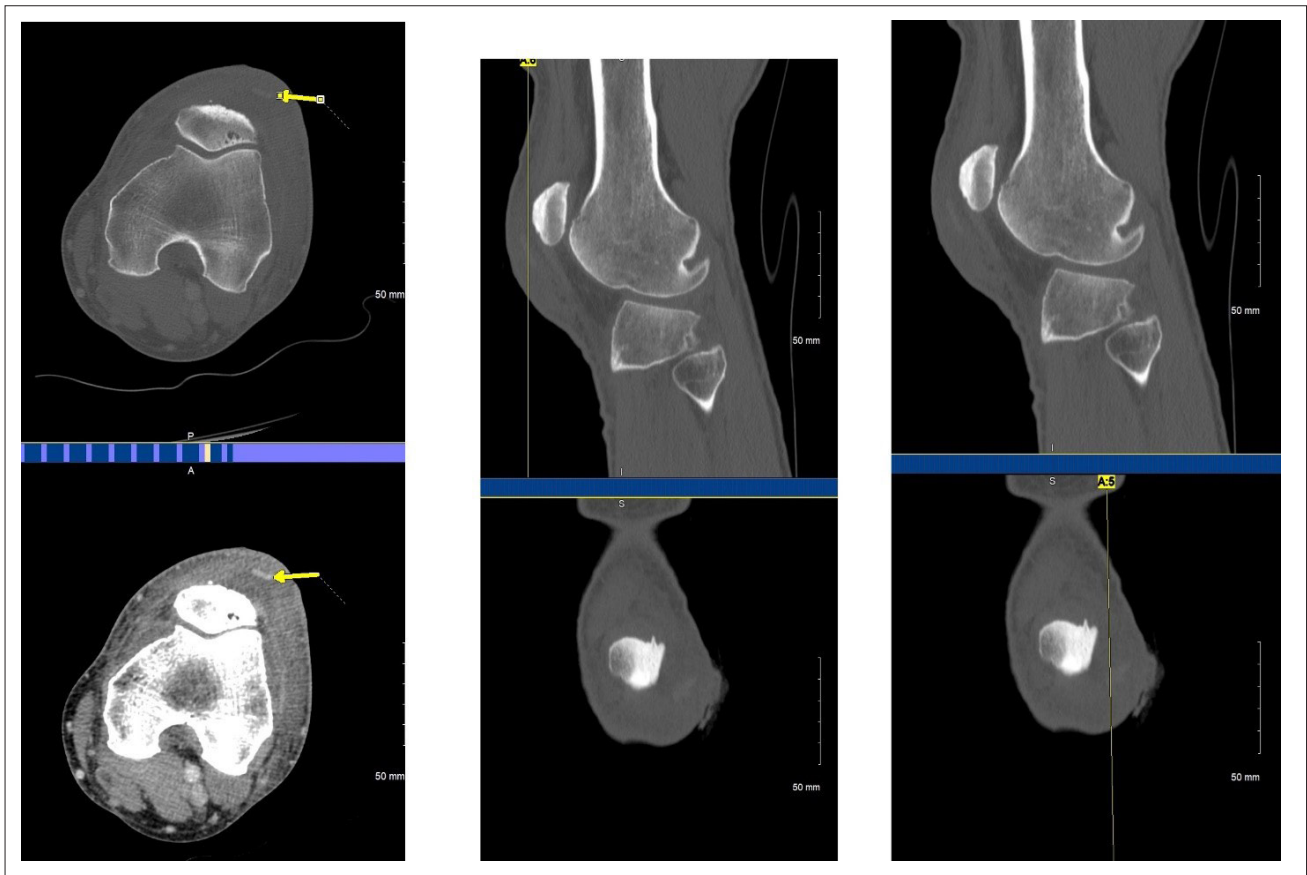
Figure 2 :

**Figure 2 :** Axial, sagittal and coronal non contrast CT of the left knee, the yellow arrow denotes what was originally dictated as a “small hematoma measuring 1cm x 0.5 cm with prepatellar swelling” The arrow represents the FB

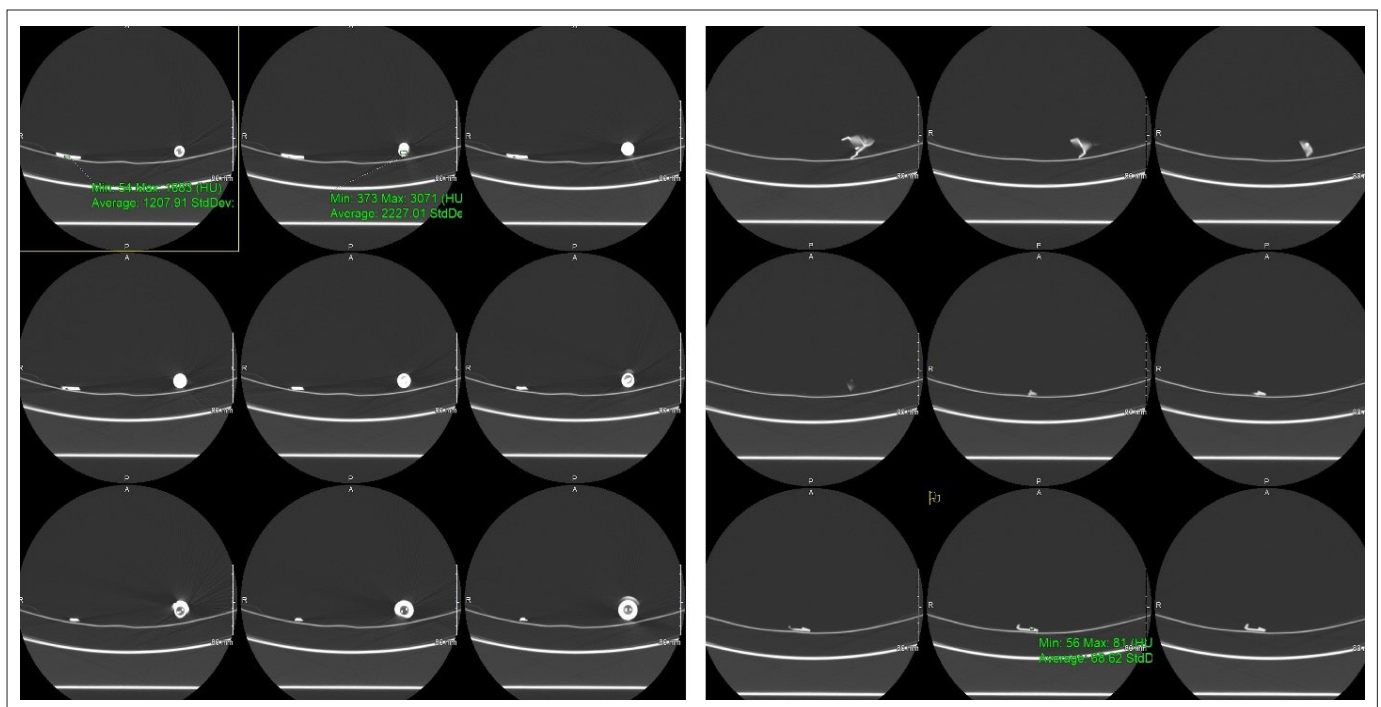
Figure 3 :

**Figure 3 :** Phantom CT of glass (HU 1207.91), metal (HU 2227), and plastic (HU 88.62) from a broken taillight imaged in the same CT scanner the as the patient was imaged in.

studies (Table 1). Plastic from an automobile light in the CT scanner at our medical center had a HU of 88.62 (figure 3), and the study was dictated as a hematoma. A hematoma usually has a HU of 40 - 60 (Table 1); depending on the onset (acute or chronic), the HU can range from 28 - 82 (Singh, 2017) because of the difference in calcium and iron based on the time. Identifying that car taillight plastic averagely attenuates at 88.62 HU at our institution highlights an area of improvement that hematoma should not have been suggested. The purpose of this case is to prevent further deleterious events from happening in the future. Based on the medical record, a piece of glass was pulled out of the surgical wound, this is not probable because glass has substantially higher attenuation than plastic on CT (Table 1). In addition, if the FB was glass, it would have likely been easily identifiable on x-ray due to the radio-opacity of glass.

\*Plastic had lots variety of HU in the literature ranging from -100 to 500 (Alfuraih 2022, Carneiro et al., 2020, Modjtahedi 2015, Tseng 2015) The values of 10 - 100 were chosen because it most closely encapsulates the most common values seen in the literature. (Alfuraih 2022) had plastic attenuating at 73 HU which resembled the CT scanner at the hospital it was imaged on (can be seen in Figure 3)
