# Cholangitis Due To Cholecysto-Hydatid Cyst Fistula.

Nizar Khedhiri, Haithem Zaafouri, Meryam Mesbahi, Anis Ben Maamer.

Department of General Surgery, HABIB THAMEUR Hospital, Tunis TUNISIA Faculty of Medicine of Tunis. University of Tunis El Manar, Tunisia.

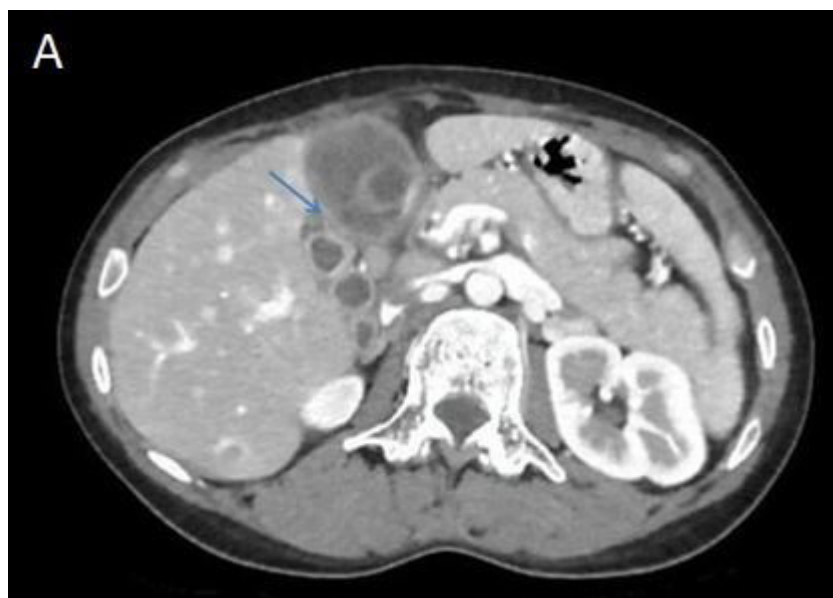
**Figure 1.** Computed tomography images of the thick-walled cyst compatible with hydatid cyst and a fistula between the gallbladder and the hydatid cyst.

Ultrasound and abdominal CT scan showed a 43\*41\*56 mm cystic formation of segment IVb of the liver communicating with the gallbladder via a fistula, as well as a discrete dilatation of the main bile duct (**Figure 1**).

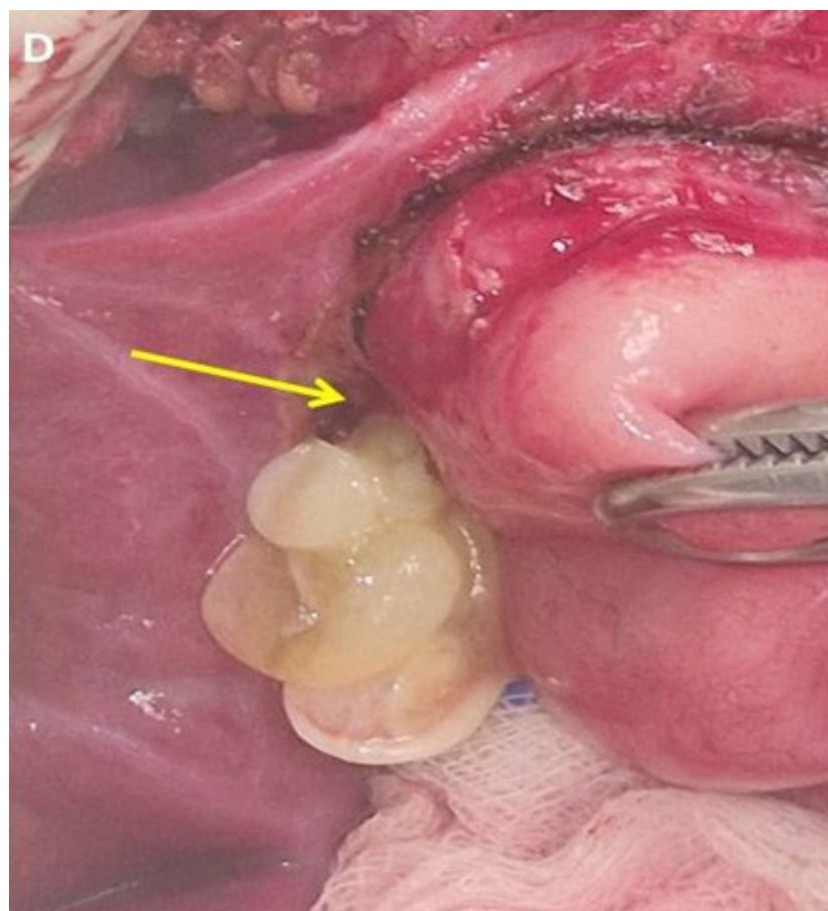
**Figure 3.** Photograph of the abdomen of the patient, showing the fistula between the cyst and the gallbladder.

A diagnosis of rupture of a hydatid cyst into the gallbladder with a fistulous communication was made. The patient underwent a laparotomy, which confirmed the imaging findings of the fistula (**Figure 3**). The patient was treated: cholecystectomy fistulization was detected between the gallbladder and hydatid cyst. Pericystectomy was performed along with cholecystectomy following sterilization maneuvers for cyst hydatids, CBD exploration and T tube. The postoperative period was uneventful.
